> Waterproofing Systems and Technical Solutions

> It Park - Car Parking Repair

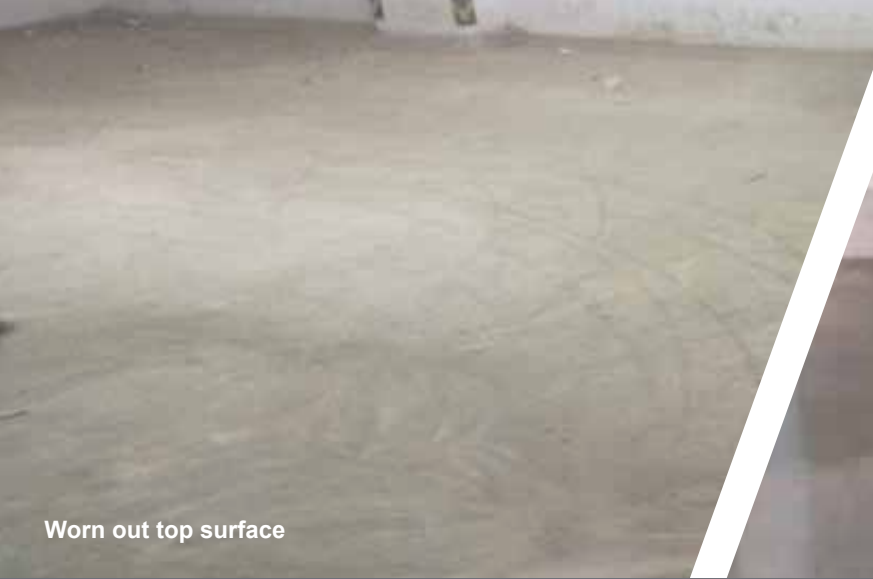
Worn out top surface

Car parking area which was constructed three years ago using IPS (Indian patent stone) flooring, observed weathering off top layer due to low strength and continuous vehicular movement.

With a simpler solution in mind, PAREX India did a sample of 2 meter sq which was put under observation for a month. It was approved and work order being released.

Jobsite was executed over weekend and traffic was open to movement on Monday morning. Finishing given with scratch lines to ensure anti- skidding.
